SERVICE BULLETIN

BOA-SKI INC.

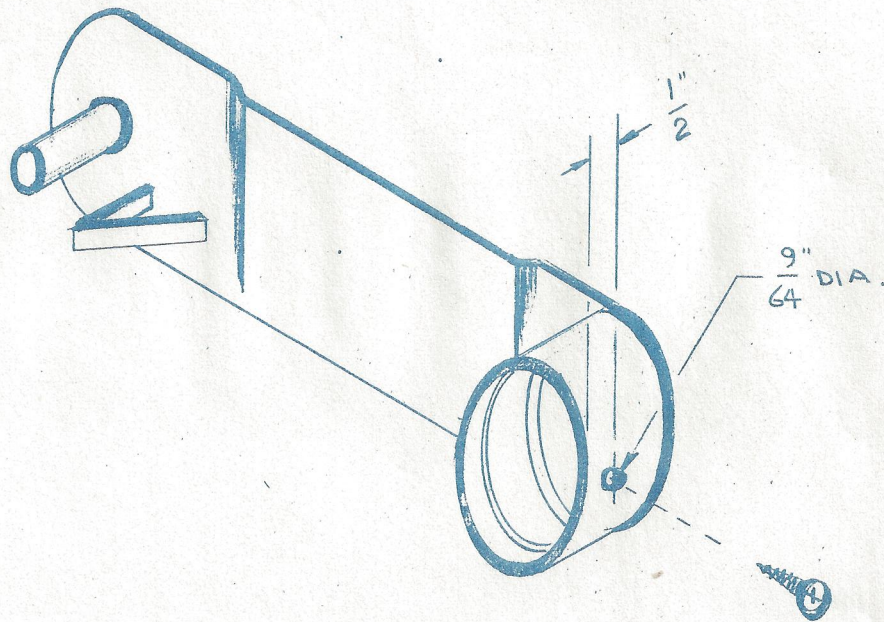
During recent field tests, we have found that the rear take-up axle grease seal has a tendency to be forced out of its seat by the side action of the self aligning bearings. To prevent this and to assure trouble free performance for the customer, we request that a $\frac{1}{2}$ - 8 self tapping screw be installed as per instructions on all units below serial 26905..

Nous avons trouvé, lors de récents tests, que le joint d'étanchéité sur l'essieu arrière avait une tendance à être arraché de son siège par la force du coussinet à billes. Pour prévenir ceci et éviter tout trouble de performance pour le client, nous demandons qu'une vis $\frac{1}{2}$ -8 soit installée comme illustrée ci-haut sur tous les unités fabriqués avant le numéro de série 26905.
